Detecting No Controller

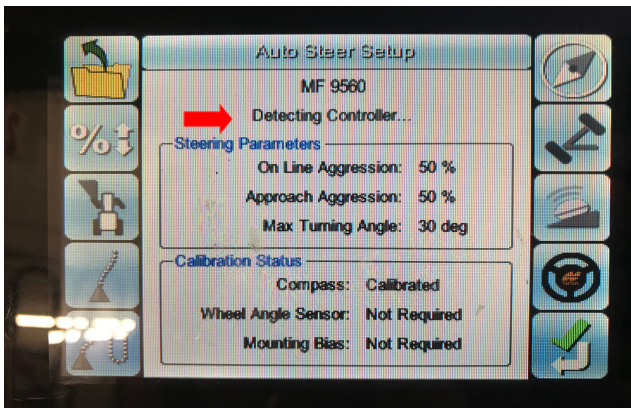
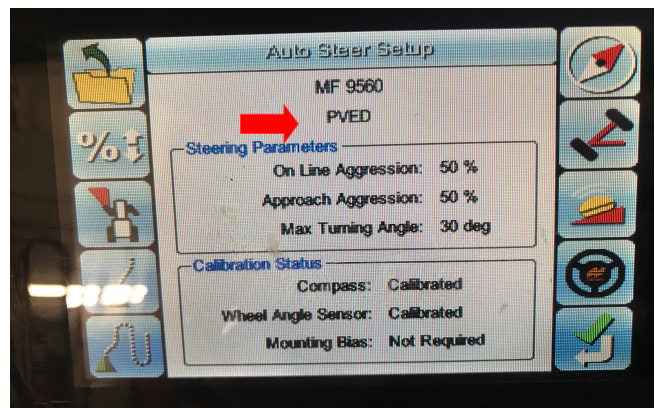
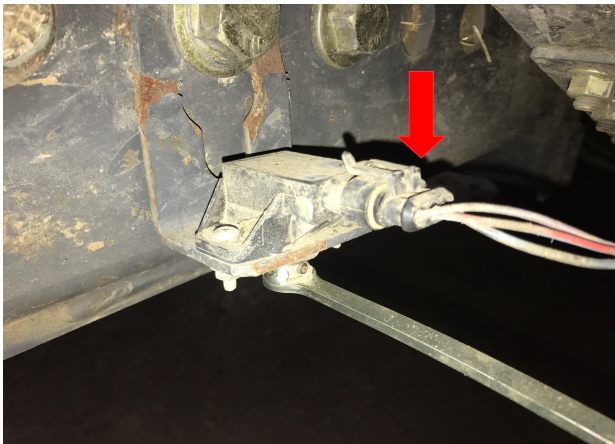
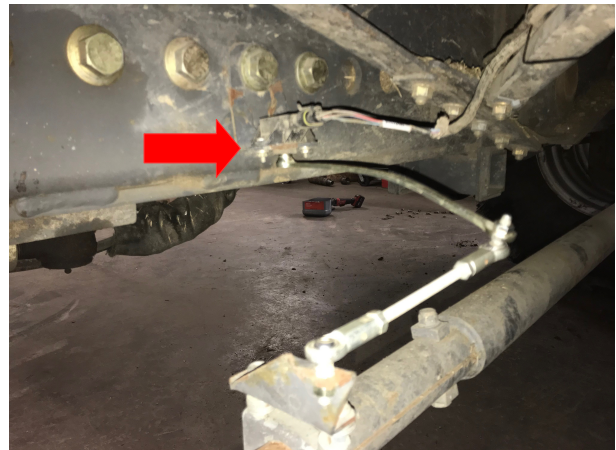
On 9000 series MF and Gleaner combines using a Topcon System 150 auto steer controller - GX45 console and AGI3 antenna. There are occasions where you may not detect Steering Controller - "Detecting Controller" in the steering profile page. One thing to check is the wheel angle sensor (W.A.S.) wiring at the sensor it self. There are times that a broken wire near the sensor will not allow Steering Controller to be detected. This can be verified by disconnecting the sensor harness plug. The wheel angle sensor is located at front of rear axle.
